### **Zimbrick Mercedes-Benz of Madison**

### **Automobile Status Report**

2005 Porsche BOXSTER Date April 30, 2021 VIN WP0CB29885U731805 **Mileage** 120700 RO# 494203

#### Multi-Point Inspection Form

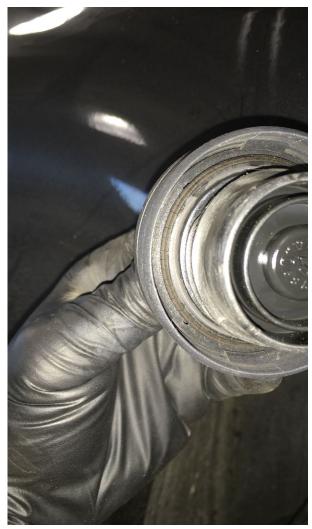
Gas Cap

### Gas Cap: gasket cracking, can lead to check engine light

If not replaced, when necessary, will cause the "Service Engine Soon" light to come on.

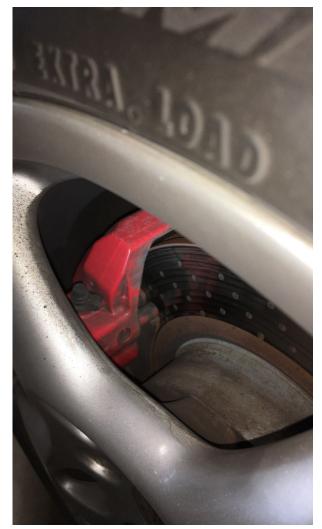
Pads&Rotors

# Brake Job - Front (Replace Pads and Rotors): see measurements, rotor lip cutting into sensor wire

Brake pads must be replaced before the friction material is worn away completely. When replacing the brake pads it is best to replace the rotors as well. This will allow the braking system to work at its highest level of performance, and will also allow the new pads to have the longest life possible.
